# Revisiting test data of ESE rods in Cachoeira Paulista (Brazil, 2000-2005)

A field test campaign using triggered lightning took place in Brazil during years 2000–2005 to, among other objectives, assess the action and performance of ESE (Early Streamer Emission) rods, in competition with an ordinary Franklin rod at certain distance. During the test period, only two proper attachments (altitude triggering technique) occurred to objects installed on the firing & testing platform of the test facility: the Franklin rod and an electric-field antenna. The other objects on the platform, two ESE rods, failed to intercept these lightning flashes. Other results involving flashes to the surroundings and tests with classic triggering technique are also presented and discussed. Although the test outcomes cannot be considered proof against ESE lightning rods, due to test condition constraints and the low number of events (not statistically significant), they raise serious doubts about the claimed higher efficiency of these devices.

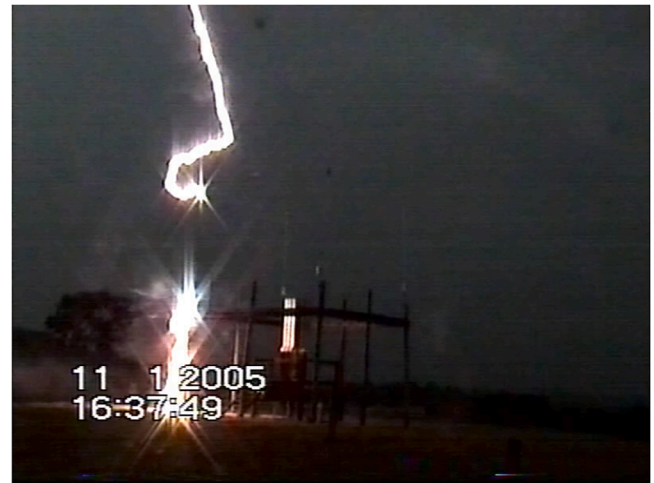
Fig. 5. Lightning strike to the electric field antenna (shot #51); altitude technique; camera A.

Fig. 5 is an image of the lightning strike to the electric field antenna (shot #51). It is interesting to see that the lightning flashed over through the platform wooden pillar under the antenna, as the antenna and its mast were not grounded.

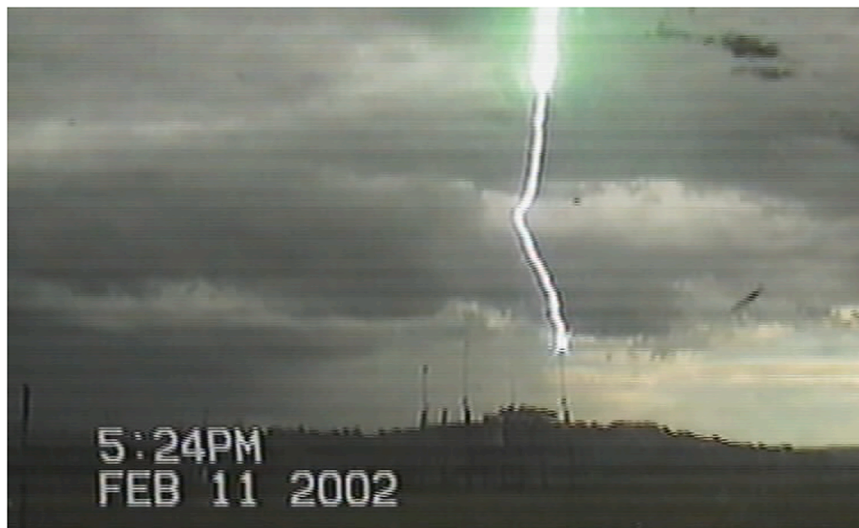
Fig. 4. Lightning strike to the Franklin rod (shot #33); altitude technique; camera B.

Fig. 4 shows the lightning strike to the Franklin rod (shot #33). This flash had its current parameters analyzed in [6]. Although it is clearly stated in [6] that the flash connected to the tip of the Franklin rod, it may not have attracted the attention of most readers about the fact that it implied failure of ESE rods under competing circumstances.

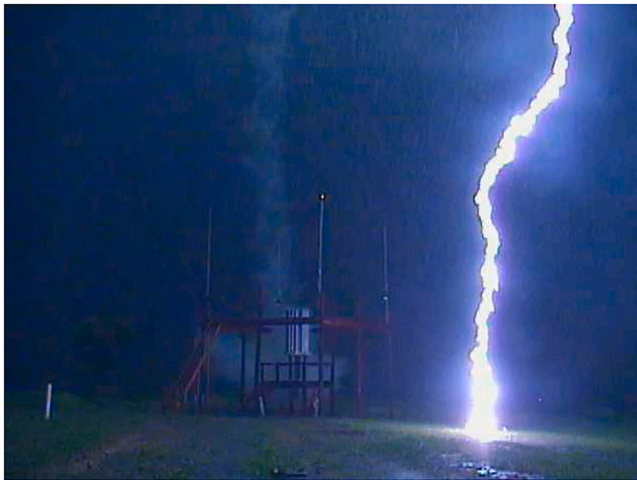
Fig. 8. Altitude triggered lightning (shot #0) strikes the ground at some 10 to 15 m from ESE-1; camera A.

Figs. 8 and 9 show altitude triggered lightning after shots #0 and #3. The distance from ESE-1 to point of impact for shot #0 is between 10 and 15 m and from ESE-1 to #3 is between 60 and 80 m. In both cases, the strike points are within the protection area of ESE-1 as displayed in Fig. 6, but also for ESE-2 if the peak current data of both flashes are considered: -54 kA and -19 kA (LPATS/IMPACT).

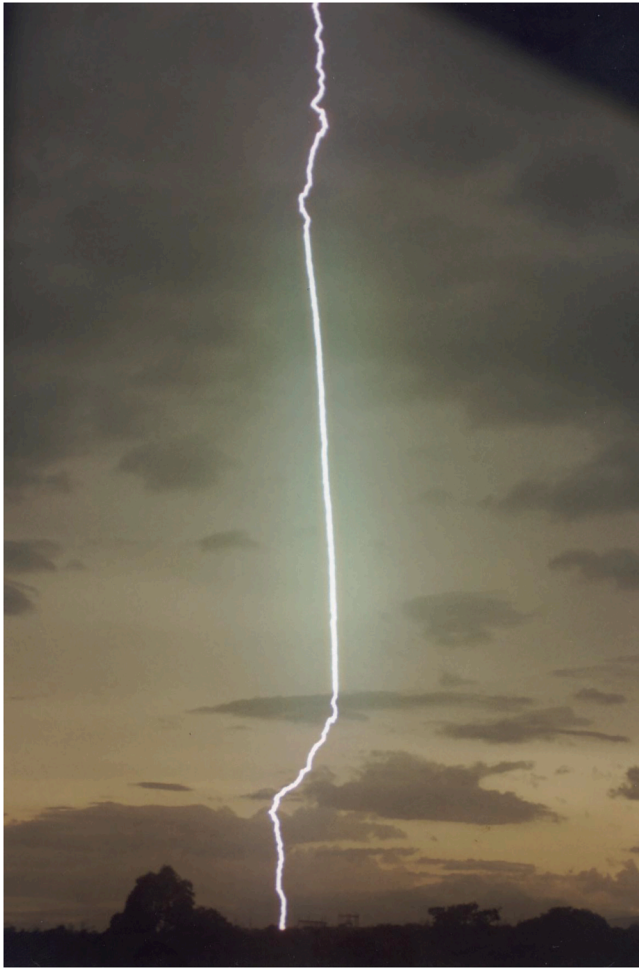
Fig. 9. Altitude triggered lightning (shot #3) strikes the ground at some 60 to 80 m from ESE-1; camera E.

The still camera “E” is not mentioned in the known published papers. One of the photographs taken by this camera is shown in Fig. 9.

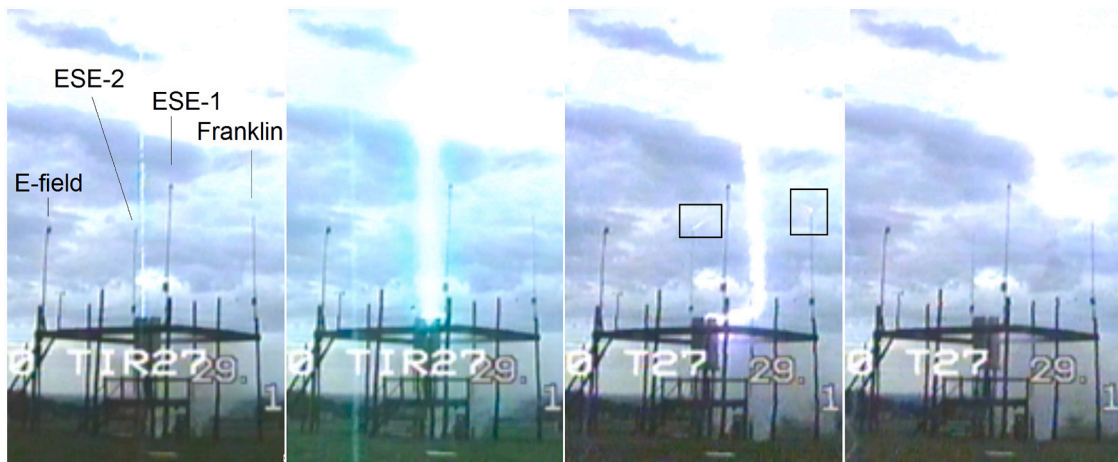
**Fig. 11.** Classical triggered lightning (shot #27); a) Wire burns with ICC; b) Subsequent return stroke; c) Another return stroke with channel apparently leaning to Franklin rod; d) Channel jumps to Franklin rod; camera B.

Shots #27 (to Franklin) and #49 (to ESE-1) are shown in Figs. 11 and 12, respectively. The pictures are taken from video frames selected to represent similar stages of the two discharges on the two figures: ICC, subsequent return strokes, channel leaning to one side due to wind and jumping to rod.

Note in the two small boxes in Fig. 11c that both ESE-2 and Franklin rods emit streamers (or leaders) toward the ionized channel, even though the channel was already connected to ground (via launching tubes).
